Environmental Assessment

**Adaptive Reuse Potential of Building 291
at Mountain Home Air Force Base, Idaho**

Feasibility Study – FINAL
Ready Alert Facility Building 291
Mountain Home Air Force Base
Elmore County, Idaho

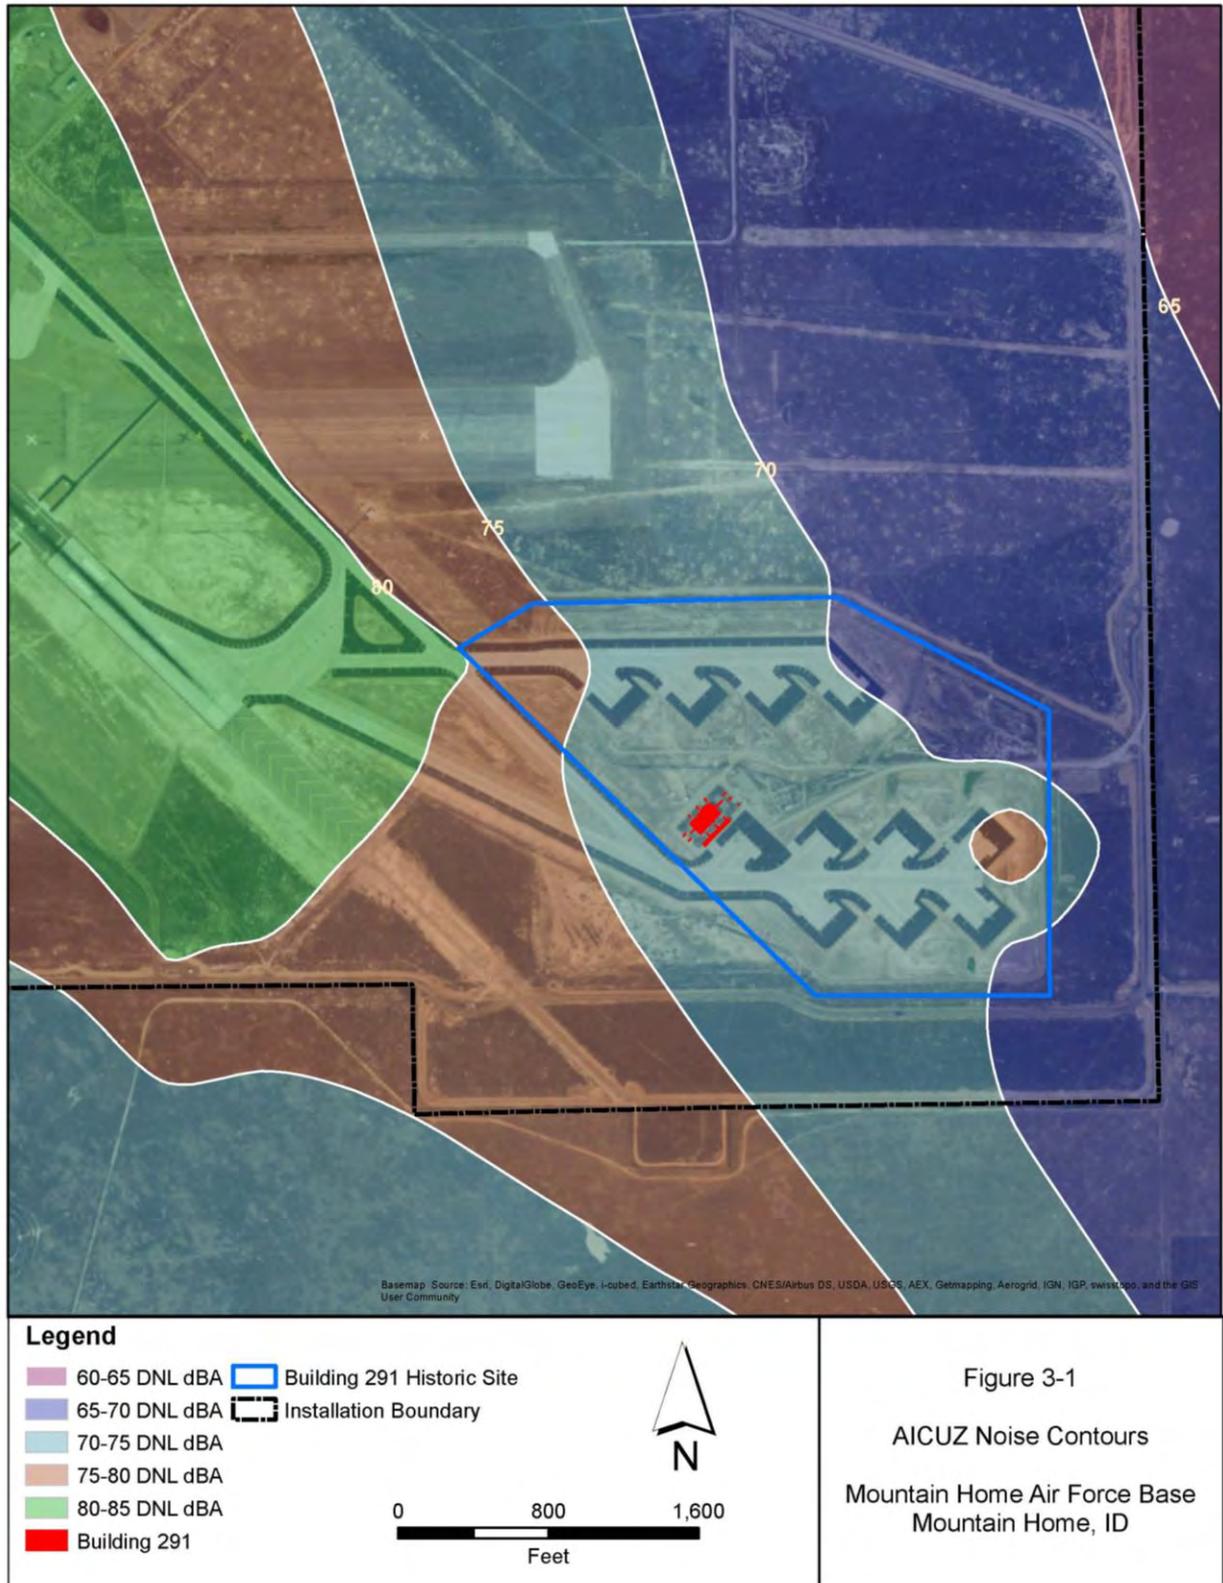
Figure 3-1 AICUZ Noise Contours

14 The noise contours (Figure 3-1) are primarily driven by flight operations from aircraft stationed at
15 Mountain Home AFB. Noise levels at Building 291 are between 70 and 75 dB DNL and could
16 approach 80 dB(A) near the LOLAs and surrounding land parcels..

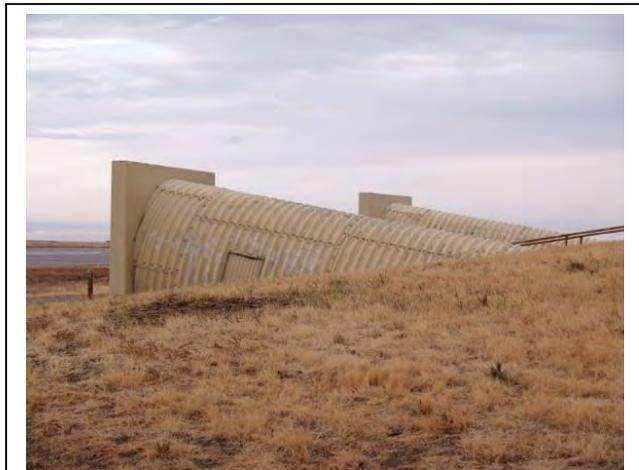
Photo 3.6-1. Vegetation adjacent to Building 291 at Mountain Home AFB showing semi-improved grounds with short dry grasses and invasive species.

31 The vegetated areas of the Alert Complex are maintained as “semi-improved” or undeveloped
32 (unimproved) “natural areas” grounds maintenance categories. Semi-improved grounds (Photo
33 3.6-1) are where personnel perform periodic maintenance primarily for operational and aesthetic
34 reasons (such as erosion and dust control, weed control, bird control, and visual clear zones).
35 Undeveloped (unimproved) usually do not requiring maintenance more than once a year, if
36 maintenance occurs at all (MHAFB 2012b).

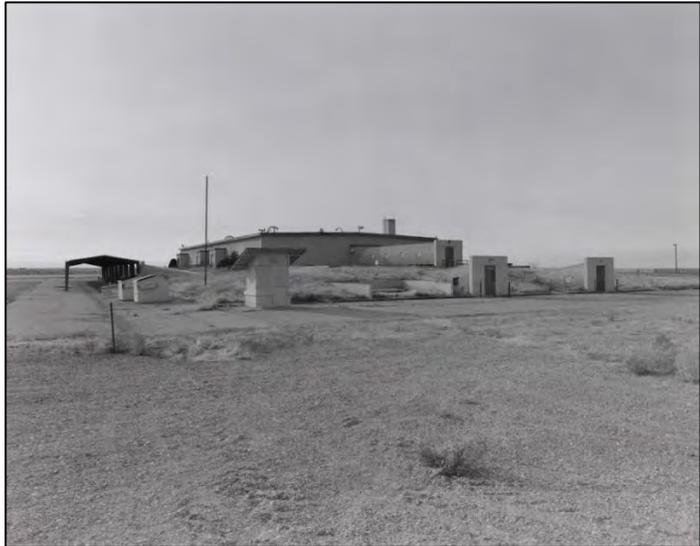
Photo 3.7-1. General Overview of Building 291,
Facing North (Taken from MHAFB 2013).

26 The Alert Complex includes approximately 103 acres and is comprised of one contributing
27 building and four contributing structures. The contributing building is the alert crew building
28 (Building 291) (Photo 3.7-1) also known as the “molehole”, two Christmas-tree alert aprons
29 (Buildings 31020 and 31021), and the road system and security fence (Figure 3-3). There are also
30 four non-contributing buildings within the Alert Facility including a 1969 traffic check house,
31 1985 carport, 1980s era tennis pavilion, and a post-1987 metal building. One non-contributing
32 structure, 1970s era tennis court, is also present within the Alert Facility. These original resources
33 have survived and represent the Cold War-era mission of the U.S. Department of the Air Force
34 under the SAC between 1957 and 1966 (MHAFB 2012d).

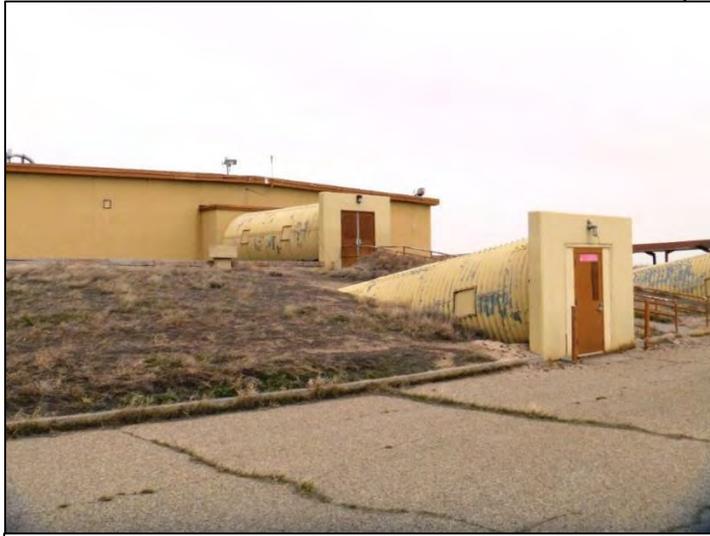
Photo 3.7-2. View of the Exterior of the Ramped Entrances.

utilities (MHAFB 2013). The first story was subterranean with access through eight ramped entrances located on all four sides of the structure which lead down to the first story (Photos 3.7-2 and 3.7-3). This type of alert crew quarter was designed by architect, Leo A. Daly in 1958, as part of the permanent readiness alert facilities. A sloped exterior earthen berm was also constructed to hide the subterranean level. Because these quarters were semi-subterranean, they were known as “moleholes” (MHAFB 2011b). The subterranean level consisted of living quarters and two sets of bathrooms. The upper level included operation support offices, a briefing room, training and

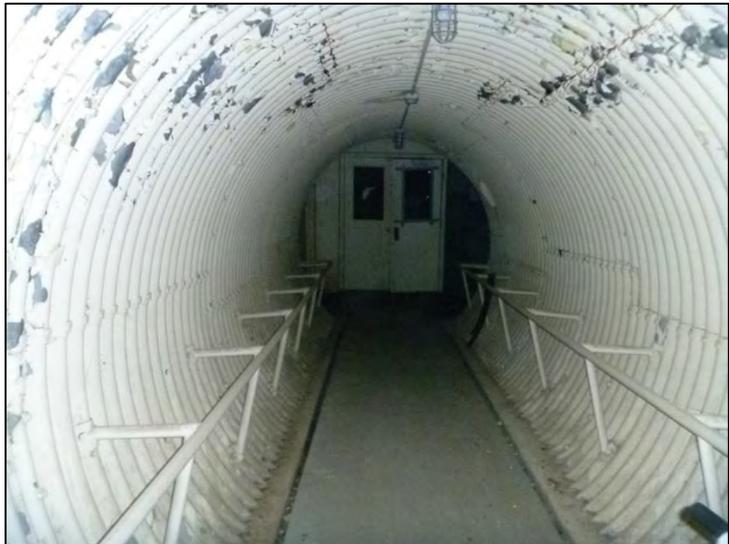
Photo 3.7-3. View of the Interior of the Ramped Entrances.

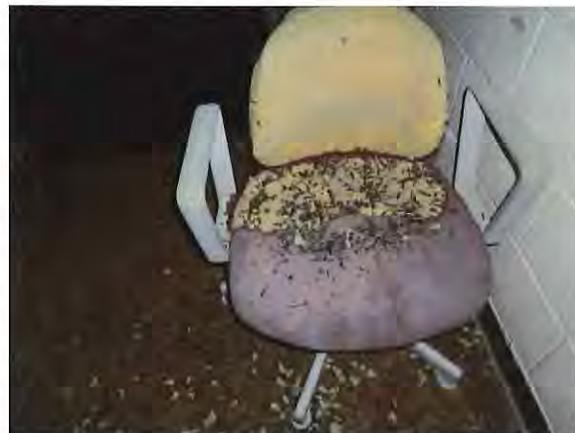
Figure 2-2: Rodent infestation / droppings

Hanta-viruses cause potentially fatal diseases in humans, who can become infected through urine, saliva, or contact with rodent waste products. Any renovation or demolition activities for the facility would require removal of the rodent droppings prior to the commencement of work. Hanta virus remediation and worker protection need to be incorporated into the “pre-cleaning and set-up” portions of the asbestos abatement work.

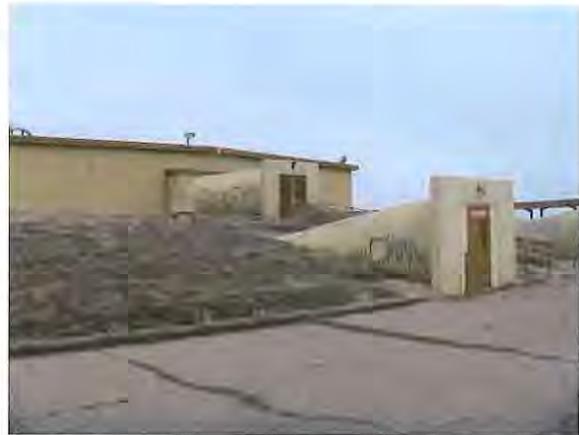
Figure 2-3: Exterior view from the east

Building Exterior: The building shell consists of reinforced concrete and concrete masonry units (CMU) walls with exterior applied plaster with a painted finish. The walls appear in good condition with no stress fractures or other damages observed. Based on the age of the facility, the building joint seals are in acceptable condition. The exterior of the building requires conditioning and new paint, particularly at the corrugated metal entrance tunnels. The access tunnels require removal and replacement of windows, the installation of security bars as a deterrent from vandals, and new door/door hardware to ensure security.

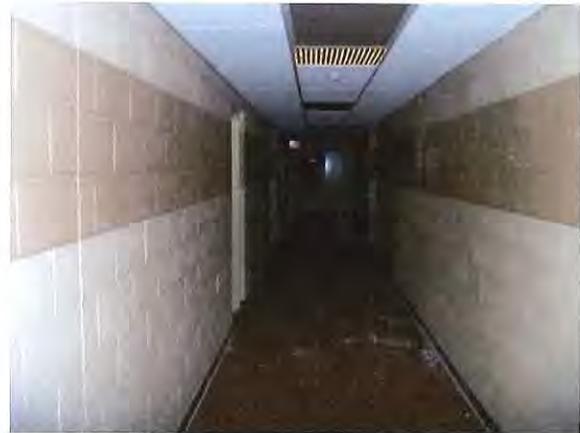
Figure 2-4: Typical interior lower level corridor

Building Interior: The building interior consists of painted reinforced concrete and CMU partitions. The office areas in both structures are finished with carpet with vinyl base, or VCT (Vinyl Coated Tile) flooring, and lay-in suspended ceilings throughout. It appears that in several areas, a secondary, lower ceiling was installed. These varied from drywall systems to suspended tile systems.

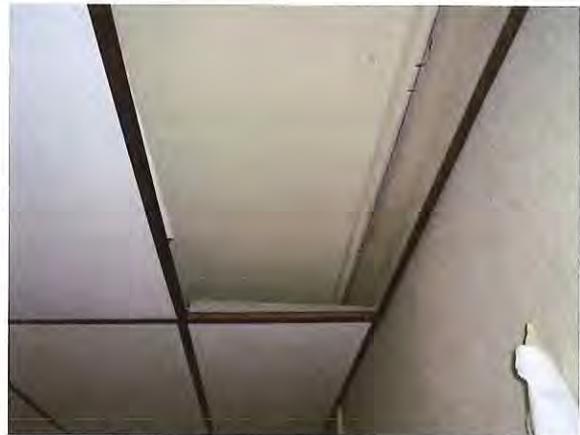
Figure 2-5: Typical ceiling at lower level interior office

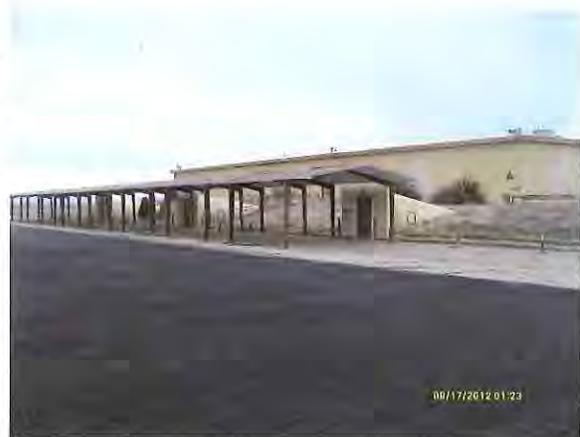
Figure 2-6: Exterior view from the southeast

Site Structural: There are several exterior structures associated with Building 291. A parking canopy located on the south side of the facility appears to be in good condition with no visible deficiencies. Secondary structures such as the guardhouse (Building B289), and the Mechanical / HVAC facility (Building B31291) are in poor condition. Various miscellaneous concrete slabs that once provided foundations for equipment surrounding the facility appear to be in good

condition, although no apparent use or need has been determined. No observations reflect any movement of soils or compromised retaining structures. Many of the paved areas surrounding the facility are asphalt, which show signs of deterioration and cracks where vegetation is apparent.

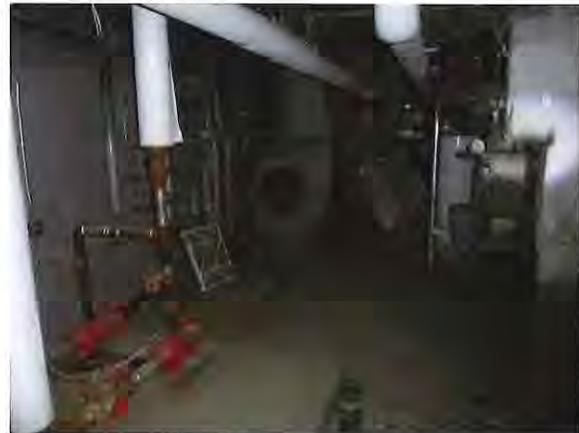
Figure 2-7: Mechanical room at lower level

Chilled Water System: The principal components of the chilled water system are the air cooled chiller (compressor, condenser, expansion valve, evaporator), and the chilled water pumps and pipes. The components of this unused closed circulation system show physical signs of deterioration. This contributes to impaired efficient operation of the system. Physical damage to the chiller include missing and bare wiring, deteriorating insulation, corrosion, microbiological growth from rodent droppings, and rust in the system. Corrosion results in metal loss, making the system susceptible to contaminants such as air and moisture that are introduced through crevices.

Steam System: The heating system used is a two (2) oil-fired boiler system added during a late 1990s renovation. This system is composed of a heat producing source, a boiler, heat exchange, a distribution system, condensate pumps, pipes, burner by-products elimination system, and control mechanisms (such as the thermostat and master switch). The boiler, originally installed in the 1960s, is located in the basement and has been decommissioned. The facility's steam system is made up of steam distribution piping, steam traps, tracer lines, condensate piping, vents, inlet valves and condensate pumps. The system has been inactive for an extended period of time with water in the system and shows signs of corrosion and rust.

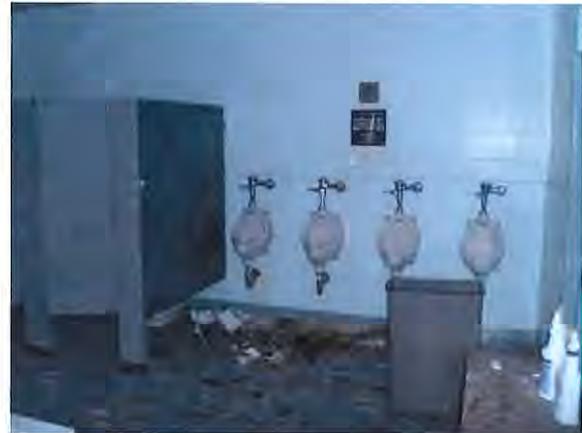
Figure 2-8: Rodent infestation at Men's restroom

Domestic Water System: The water system is comprised of copper and galvanized piping. The expected life of galvanized pipe is 40 years because corrosion will occur in the pipe where holes are difficult to locate and service. During the visual inspection, no sign of water damage to the walls was found.

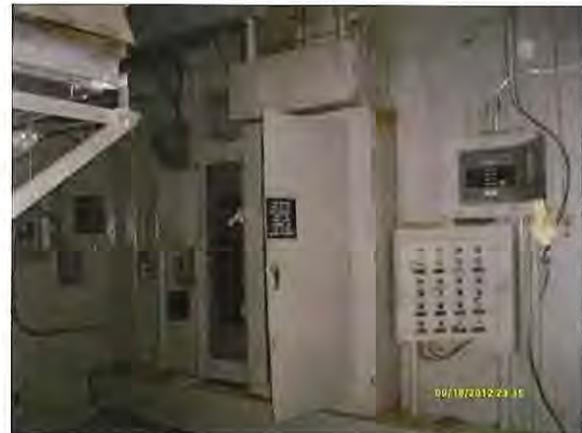
Figure 2-9: Main electrical panel at mechanical room

Main Switchgear, Controls, Disconnect Switches: Most of this equipment seems to be of original 1950s vintage. Generally, these are at end of life condition. Some of the breakers display water intrusion damage. For reliability and life safety reasons, this equipment should be demolished. Associated electrical wiring and conduits can be recycled.
